DEPARTMENT OF TRANSPORTATION

Quality Assurance and Source Inspection

Contract #: 04-0120F4Cty: SF/ALA Rte: 80 PM: 13.2/13.9File #: 69.28**WELDING INSPECTION REPORT****Resident Engineer:**Pursell, Gary**Address:** 333 Burma Road**City:** Oakland, CA 94607**Report No:** WIR-005449**Date Inspected:** 08-Feb-2009**Project Name:** SAS Superstructure**OSM Arrival Time:** 645**Prime Contractor:** American Bridge/Fluor Enterprises, a JV**OSM Departure Time:** 1845**Contractor:** Zhenhua Port Machinery Company, Ltd (ZPMC), Changxing Island **Location:** Shanghai ,China**CWI Name:** Luan Zhao Gang**CWI Present:** Yes No**Inspected CWI report:** Yes No N/A**Rod Oven in Use:** Yes No N/A**Electrode to specification:** Yes No N/A**Weld Procedures Followed:** Yes No N/A**Qualified Welders:** Yes No N/A**Verified Joint Fit-up:** Yes No N/A**Approved Drawings:** Yes No N/A**Approved WPS:** Yes No N/A**Delayed / Cancelled:** Yes No N/A**Bridge No:** 34-0006**Component:** OBG Assembly**Summary of Items Observed:**

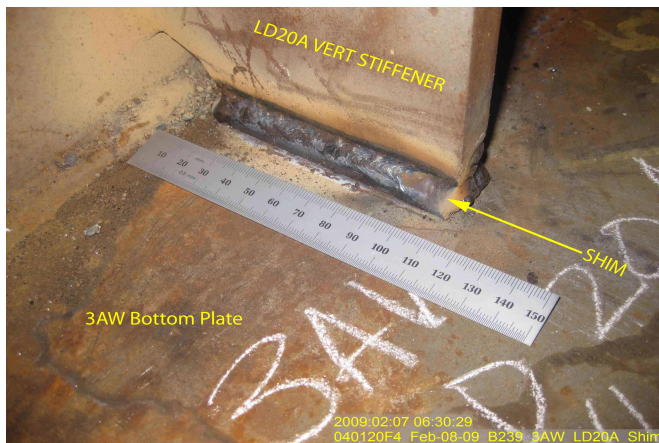
Shielded Metal Arc Welding (SMAW) in the 1G position of the shim plate for the longitudinal diaphragm vertical stiffener at panel point 19.5. The welder is identified as #066413. ZPMC QC is identified as Mr. Fu You Saen. The welding variables recorded by QC appeared to comply with the applicable WPS. (See Attached Photo)
